CAMBRIDGE HISTORICAL COMMISSION

Re: D-1100: 54 Larchwood Drive

An application to demolish the gambrel roof at 54 Larchwood Drive and to construct a new gable roof, in conjunction with a remodeling project that will change the footprint and character of the house, was received on December 12, 2006. The applicant was notified of an initial determination of significance, and a public hearing was scheduled for January 4, 2007.

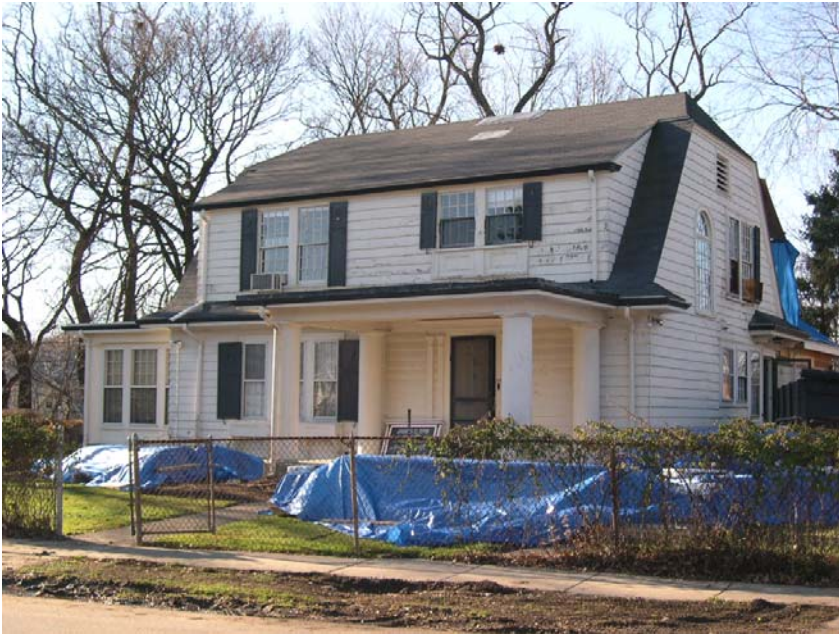
54 Larchwood Drive, December 2006

The house at 54 Larchwood Drive was constructed in 1919. It is a two-story, three-bay Dutch Colonial Revival structure with an asphalt-shingled gambrel roof, wood clapboards, and a concrete foundation. It has a rear ell, enclosed side porch, and a detached two-car garage. The windows have wood double-hung sash with a variety of light configurations, including eight-over-eight, nine-over-nine, and twelve-over-twelve.

The current condition of the house appears to be good. The greatest existing threat is water damage and paint failure due to improper maintenance. Rusted air conditioner window units have caused damage to window sills and casings. Architectural details have been well-maintained, and the wide wood clapboards are serviceable. The asphalt roof shingles look to be in fair shape and the double-hung sash units appear operable. The detached garage shows a great deal of deferred maintenance, including paint failure and rust seepage from the flat roof (likely from metal flashing). Overall, the house appears to be structurally sound. A permit was pulled in October of 2006 for extensive renovations to the interior of the building.

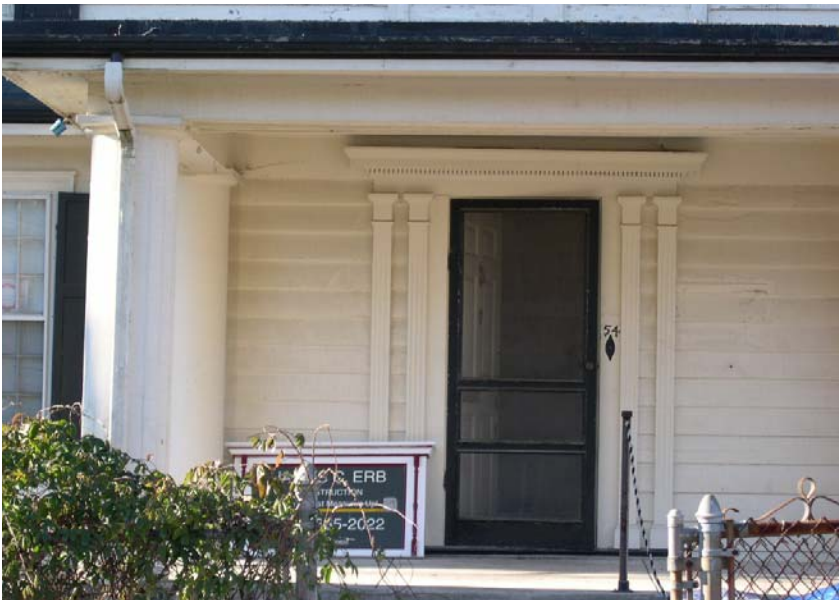
The front façade is dominated by a Classical-inspired portico, complete with wide, round columns, a flat roof, paneled door, and hooded doorway with dentils and narrow, paired pilasters. A triple window flanks the portico to the left. A full shed dormer with two double windows runs across the second floor of the house. The right side double window appears to have been reduced, with a pair of molded panels replacing the bottom half. An enclosed porch with a flat roof and a wide cornice projects from the west wall of the house. The porch was added in 1922. The right (east) elevation has a disproportionate window arrangement, including a tall, rounded-arch window, and a side entrance with a bracketed hood. A rear ell, extended by 10 feet in 1972, comes off the back wall of the house. The detached garage, added to the site in 1921, has a flat roof, wide cornice, eave overhang, and engaged end columns.

54 Larchwood Drive, front porch detail

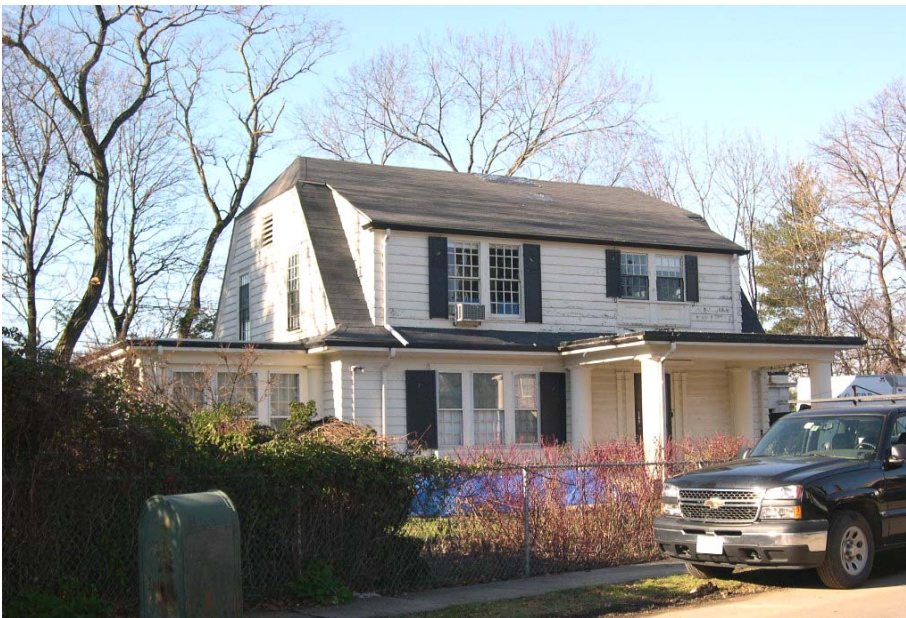
54 Larchwood Drive, December 2006

The proposal would significantly alter the building's character. The gambrel roof will be rebuilt as a side gable roof, which will raise the building height just under one foot. The shed dormer will be replaced by a series of gables, as part of an addition to the building that will enlarge the footprint and add a new portico. Other changes to the front façade will include a rounded-arch window and roof balustrade on the existing portico. The new portico will wrap around to the left (west) façade, which will also feature a second-story central porch with a balustrade and double doors.
